# Restoring Heritage Waterworks for Climate Adaptation on Curaçao: A Case Study at Hòfi Rooi Catootje

Kasper Theo Lendering

& Dimitri Schreuder

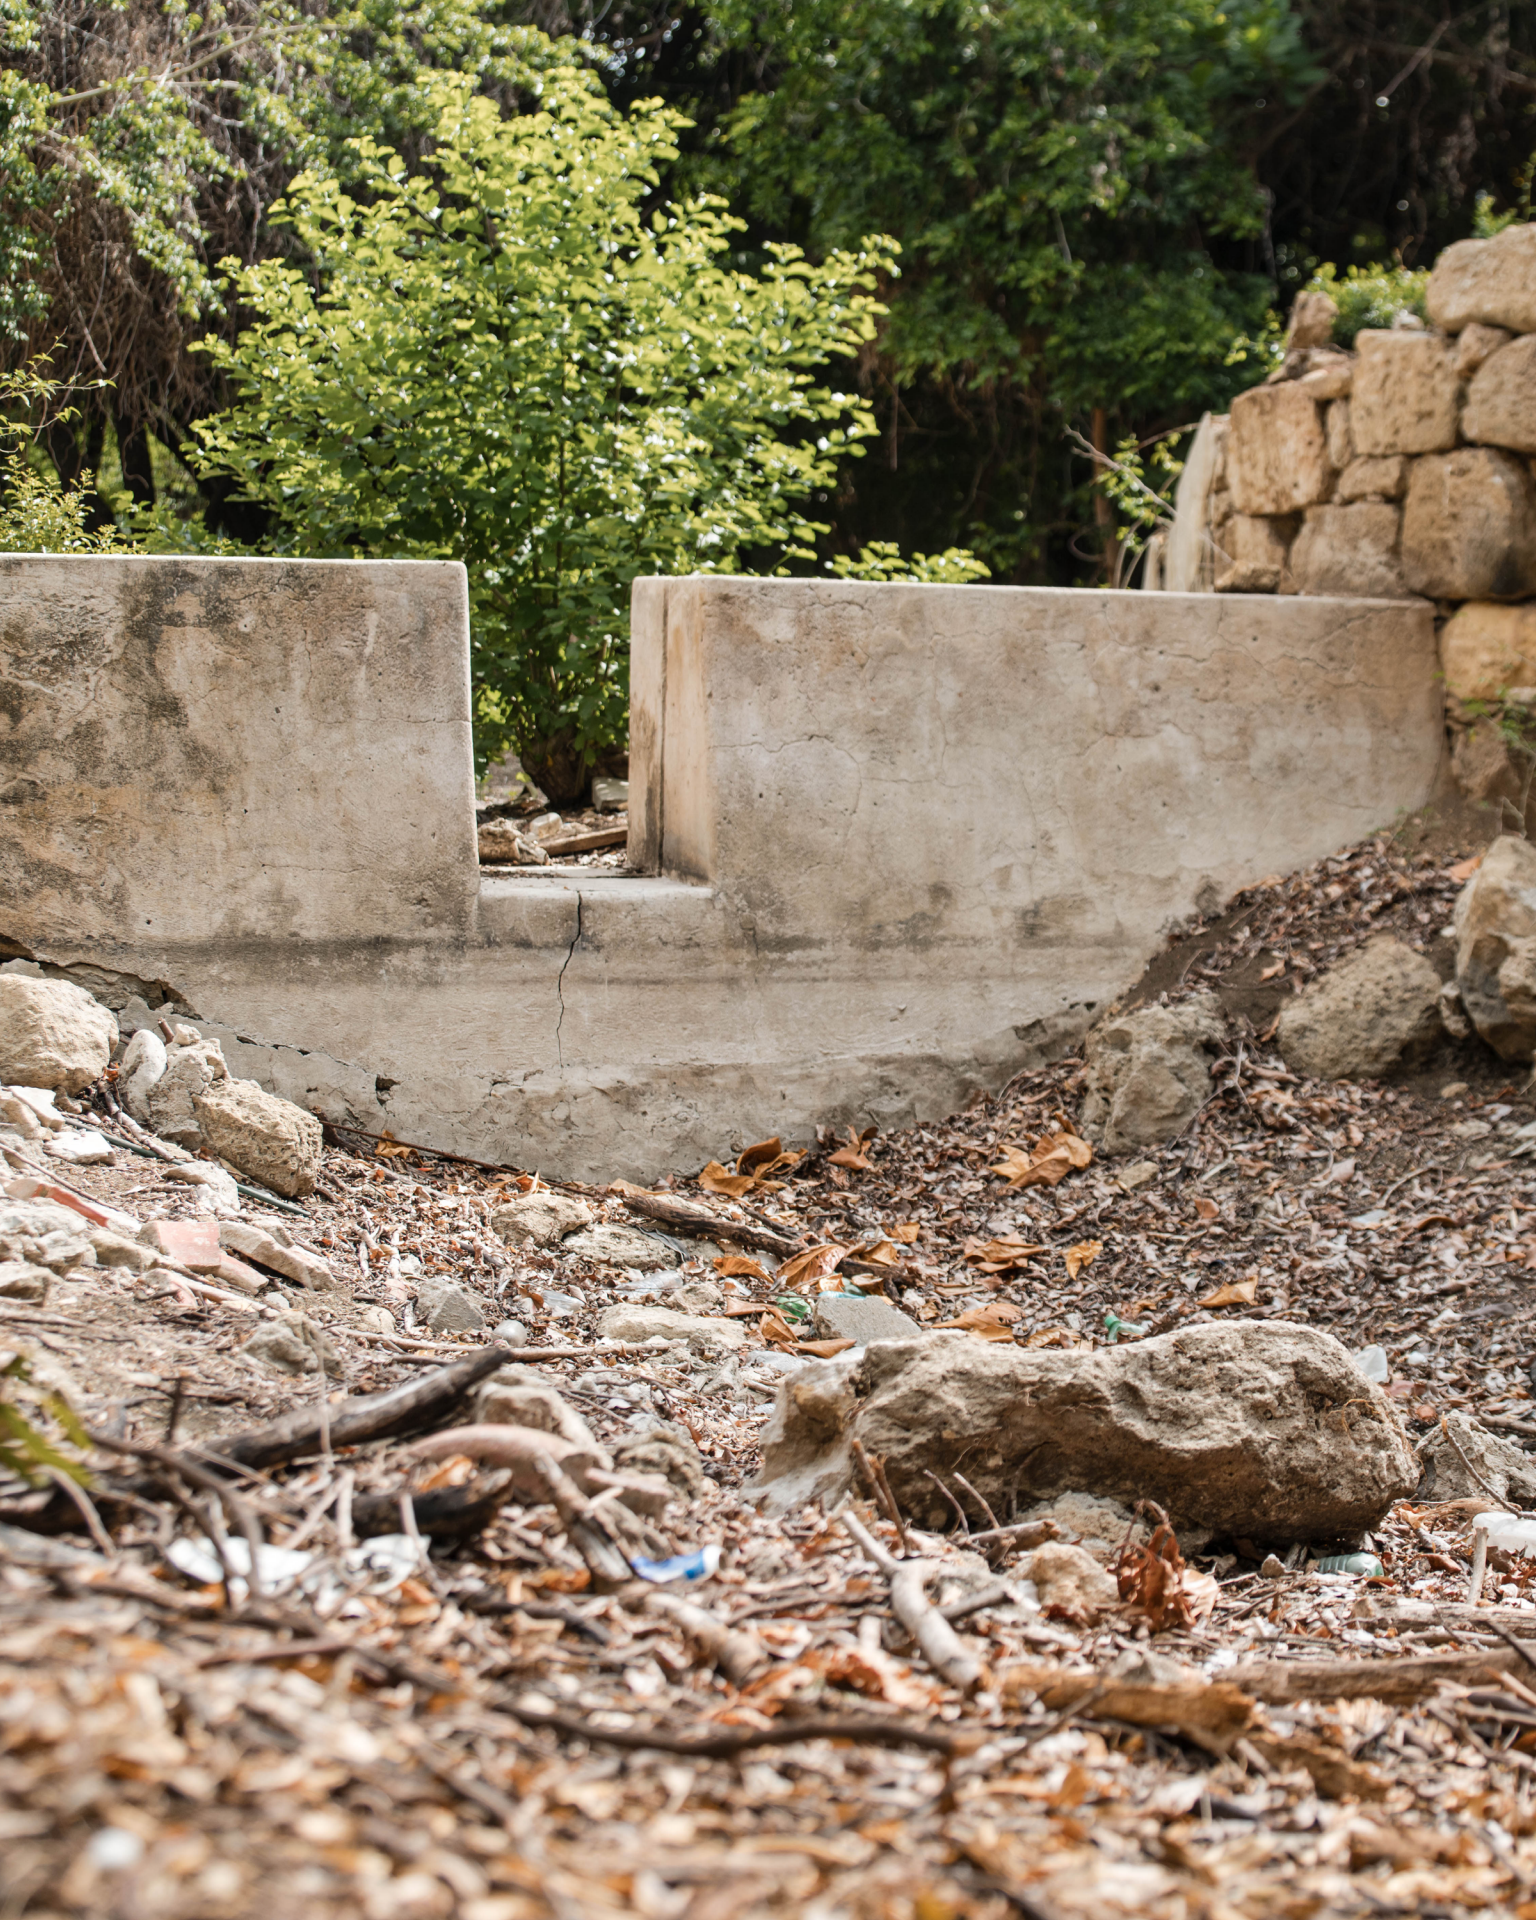
< Fig. 1 Traditional stone spillway before restauration in Hofi Rooi Catootje (Source: Kasper Theo Lendering, 2025).

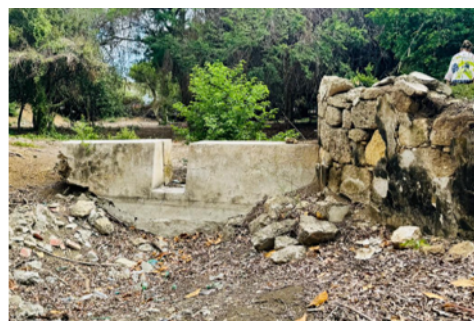
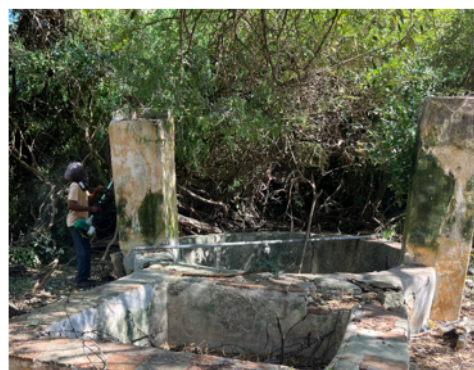
^ Fig. 3 Map of the waterworks in Hòfi Rooi Catootje, with photographs of spillway 1b (top right) and well 4b (bottom right) (Source: Dienst Ruimtelijke Ordening en Planning Curaçao, 2010).

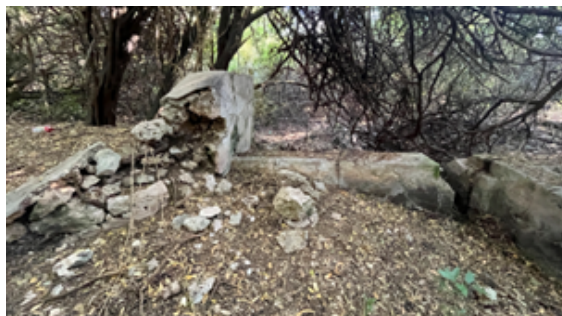
^ Fig. 4 Photo of overgrown stone spillway connected to a flattened earthen dam (Source: Kasper Theo Lendering, 2024).

The existing water infrastructure at Rooi Catootje dates to the early twentieth century, as documented on the Werbata maps (fig 5). Four large reservoirs, enclosed by earthen dams and equipped with masonry spillways, were designed to store runoff from the watershed. These reservoirs allowed sequential filling before the water continued downstream toward Schottegat Bay. Over time, however, the dams and stone structures within the *hòfi* have deteriorated. Dense vegetation has rendered many areas inaccessible, large trees have destabilized the earthen dams, and breaches are visible in several sections. In addition, the spillways and sluice gates are no longer functional (fig 4).

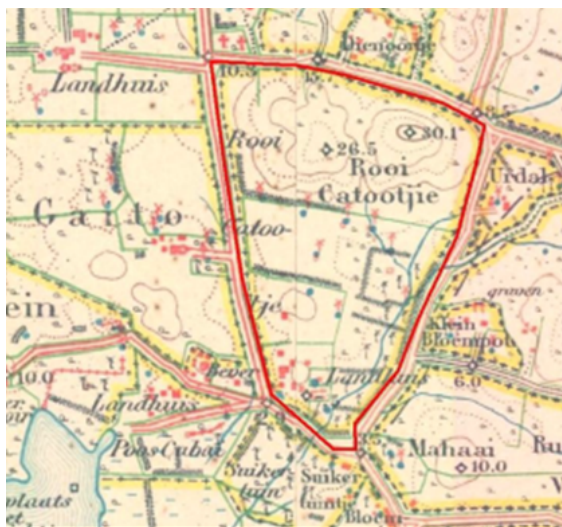
^ Fig. 5 Werbata map of Rooi Catootje (Source: Werbata Maps, 1910; personal archive of Kasper Theo Lendering).

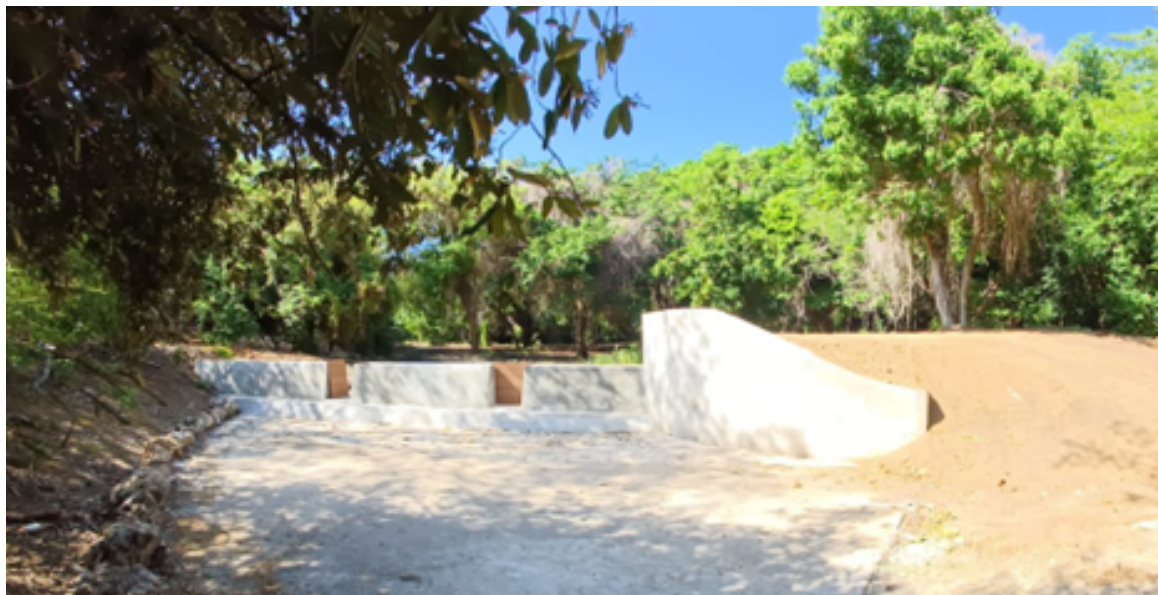
^ Fig. 7 Restored spillway (Source: Kasper Theo Lendering & Dimitri Schreuder, 2025).

5. **Selection and Implementation:** Promising interventions were implemented through the clearing of secondary vegetation and the restoration of dams and spillways, reinforcing the plantation's original water retention functions (fig 7).
